MEMORANDUM
VIRGINIA DEPARTMENT OF ENVIRONMENTAL QUALITY
SOUTH CENTRAL REGIONAL OFFICE
WATER DIVISION

SUBJECT: VPDES PERMIT # VA0006513, REISSUANCE SITE INSPECTION, TOWN OF GRETN
DRINKING WATER TREATMENT PLANT (WTP)

DATE: September 10, 2009

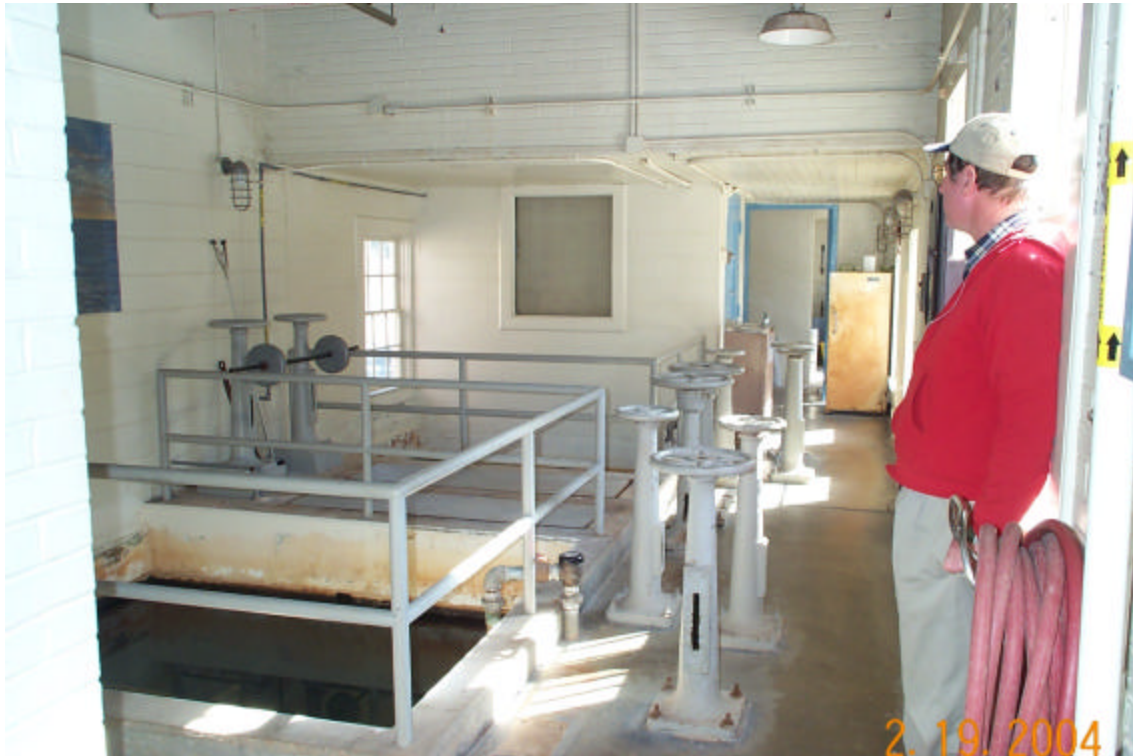
The water is then chlorinated and routed to one of the plants' three filters (note the filter picture below was taken in 2004, but no physical alterations in this unit process have occurred).

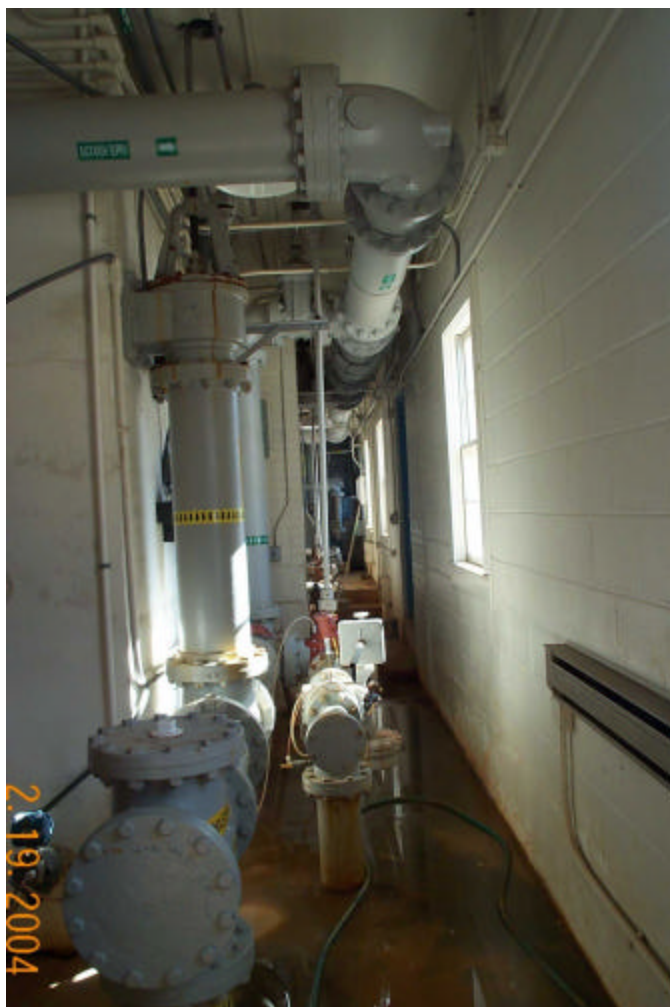
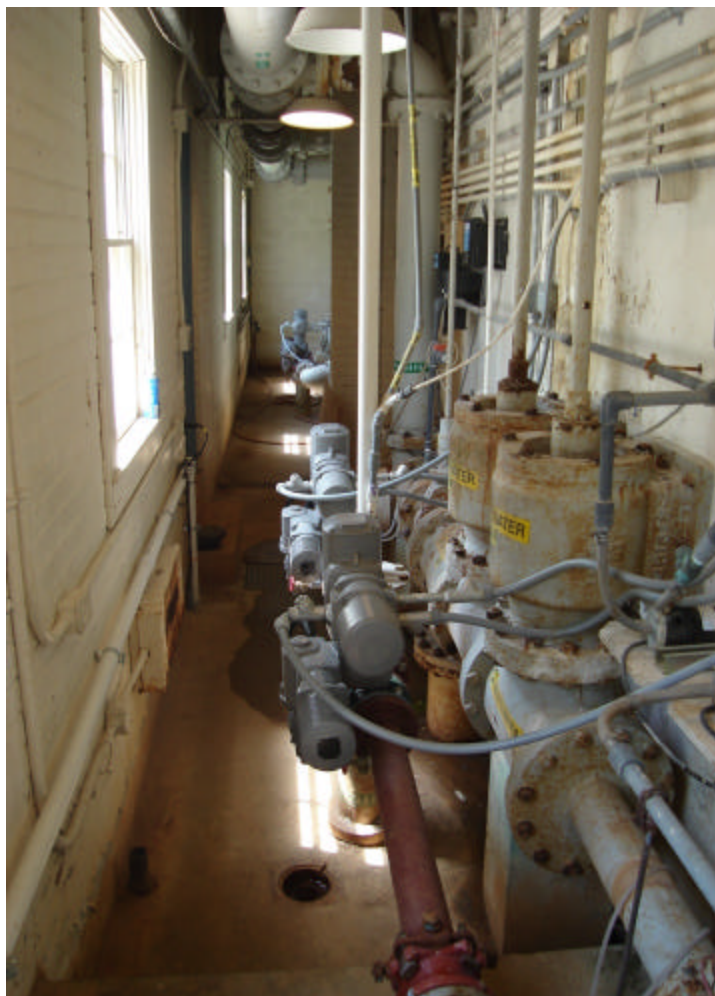
During the last reissuance inspection, significant leakage was present in the lower portion of the facility primarily associated with piping, seals etc. Since then, this area has also undergone significant

upgrades. The lower left picture was taken in 2004 (notice flooding condition), while the picture on the right was taken during the 2009 inspection (notice the dry condition).

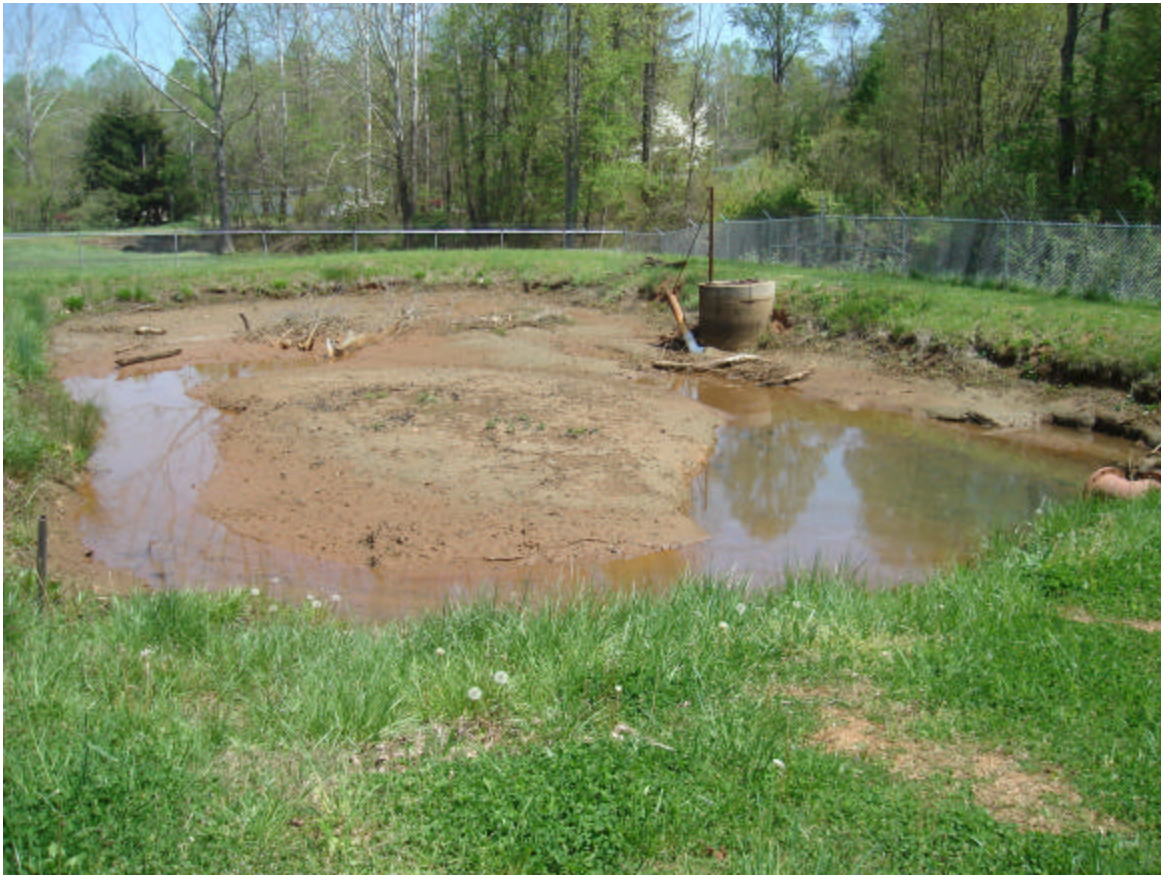
Filter backwash and settled solids are routed to the residuals settling basin (RSB), photo below.

It was noted that this basin is in need of clean-out. While the basin had been completely cleaned out since the last reissuance inspection, the appearance was very similar to that of the last inspection (below)

The inspection revealed that issues noted during the last reissuance inspection (sedimentation cleanout, bank stabilization/security, and leakage) had been largely corrected. The only item noted was that it appears the RSB is again in need of cleanout. It appears that a five year cleanout schedule may be appropriate for this basin.

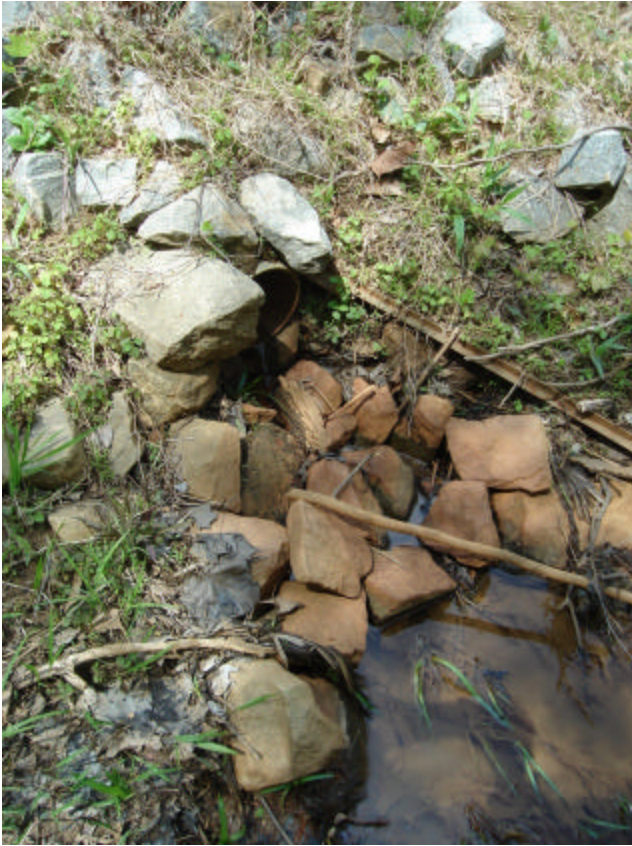
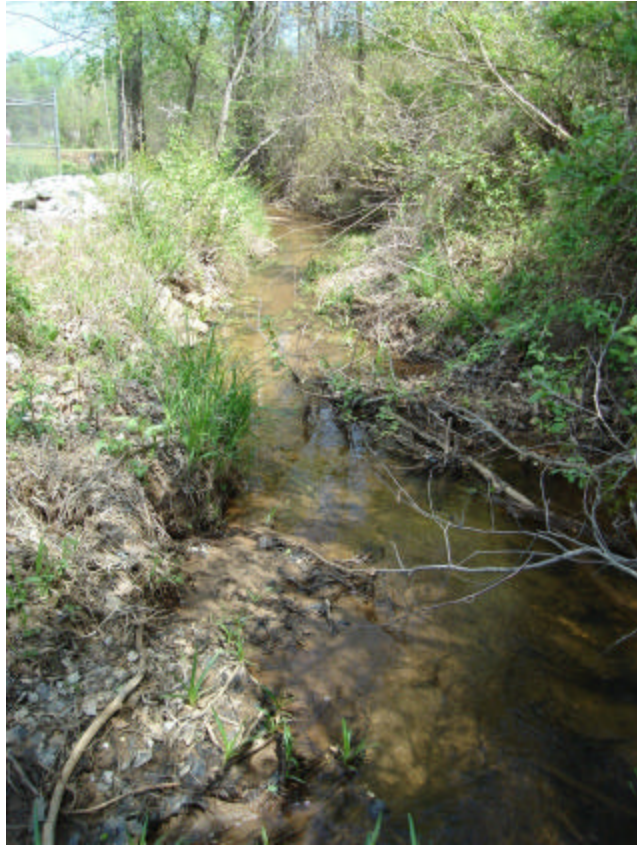
Decanted water from the RSB is discharged via Outfall 001 to Georges creek.

Notice in the above right picture that the severe erosion noted during the last reissuance inspection (below) had been corrected and the bank is now stable.

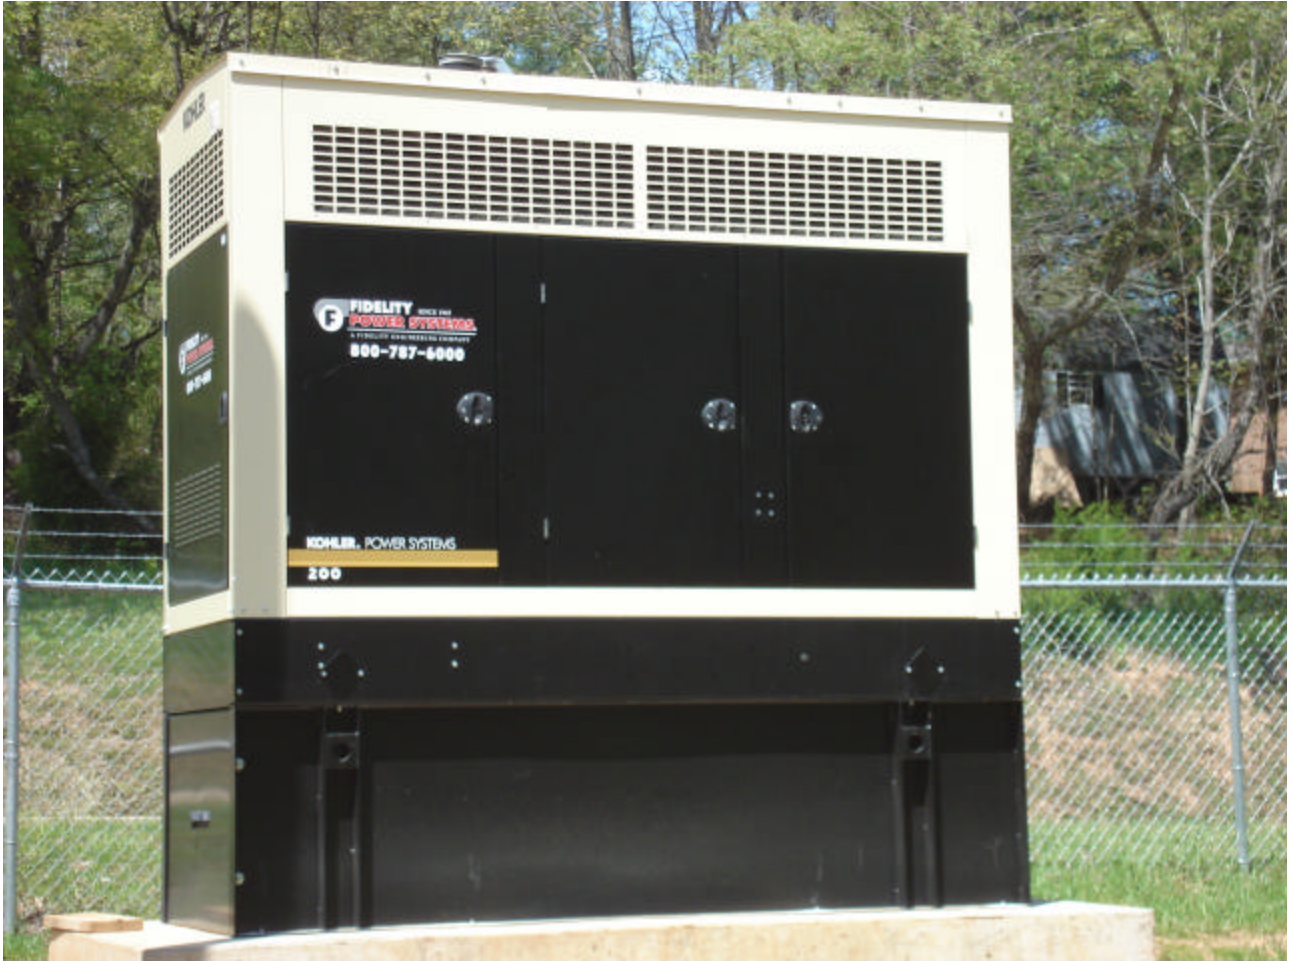
Yet another upgrade at the WTP was the installation of an emergency generator, below.
